THE CALIFORNIA EARTHQUAKE OF APRIL 18, 1906

REPORT

STATE EARTHQUAKE INVESTIGATION COMMISSION

VOLUME I, PART I

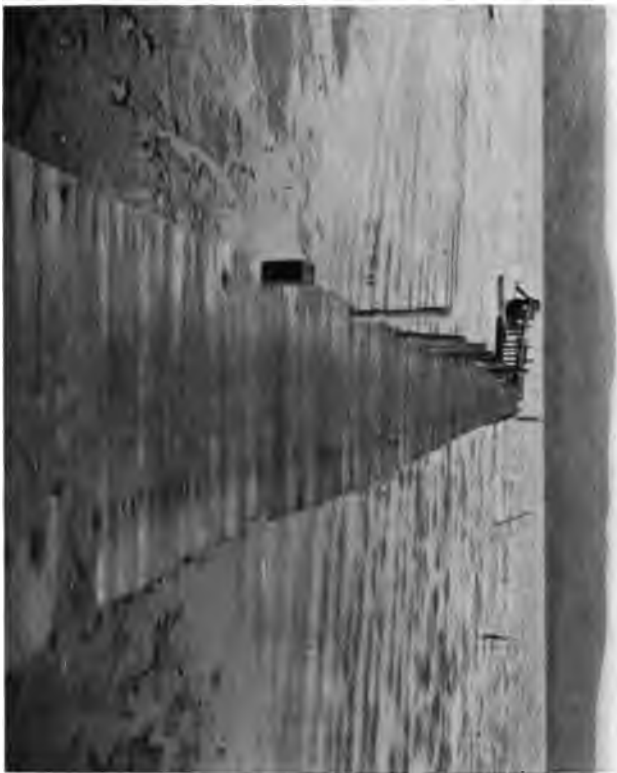
A. Martindell's pier at Inverness. Originally straight; shifted and broken by earthquake. Repaired before photograph was taken. G. K. G.

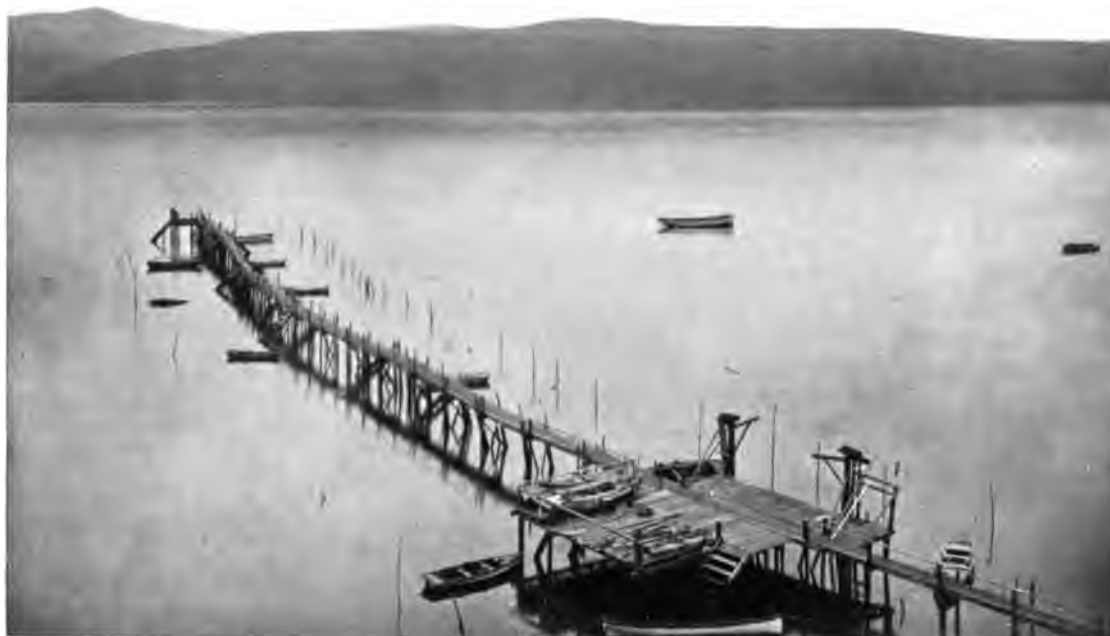
A. Bailey's pier at Inverness. Another view, position of camera being approximately same as in making photograph below, taken before the earthquake. G. K. G.

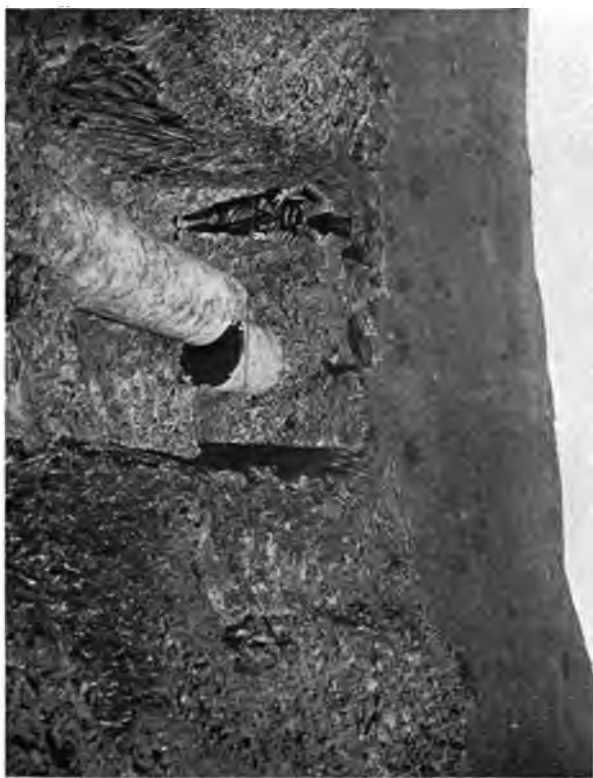
A. Offset in 30-inch water-pipe by fault. Northwest of San Andreas Lake. A. O. L.

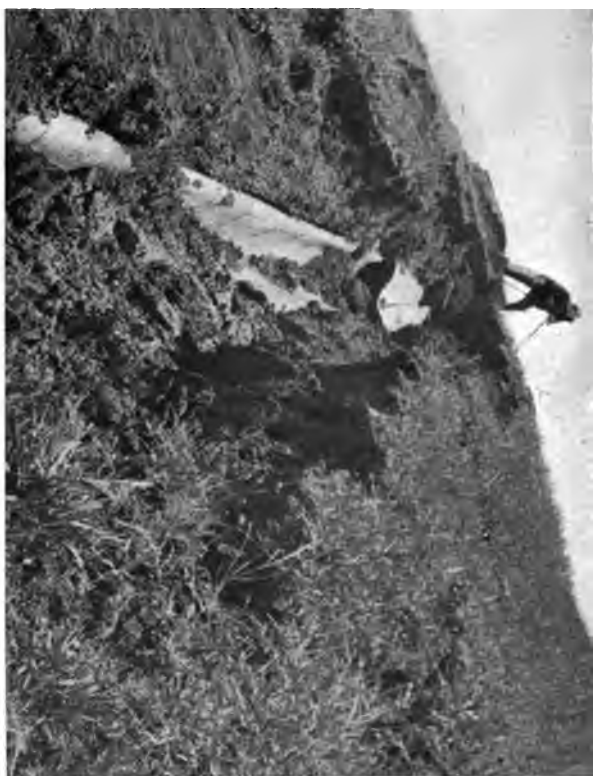
yards, due doubtless to the establishment of a partial vacuum within the pipe by the sudden withdrawal of the water from the arch in the pipe at the time of the shock, owing either to the leakage below, or the propulsion of the water induced by the shock. (See plate 60B.)

B. Collapse of 30-inch water-pipe northwest of San Andreas Lake. B. L. H.

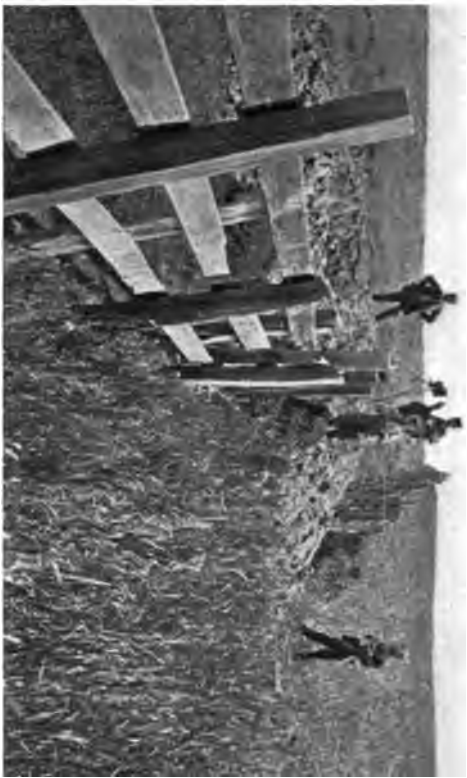
furrow. The movement was in the same direction as before, therefore a pulling apart of the pipe took place instead of a compression. There occurred two breaks in the pipe (see plate 59A), the main one at the crossing of the fault, and the other 150 yards away on the northeast side of the fault, but very near it, the pipe being almost parallel with it. At the main break, the pipe was pulled apart 59 inches, and at the other one 21.5 inches, making a total displacement of 6.666 feet. The pipe was not quite parallel with the fault and therefore there was a slight offset, at right angles to its direction, of 4 inches at the main break and 2 inches at the minor one, or a total of 6 inches. A fence which crost the fault at the main break is offset 6.5 feet. (Plate 60c.)

C. Offset of 6.5 feet in fence northwest of San Andreas Lake. C. L. H.

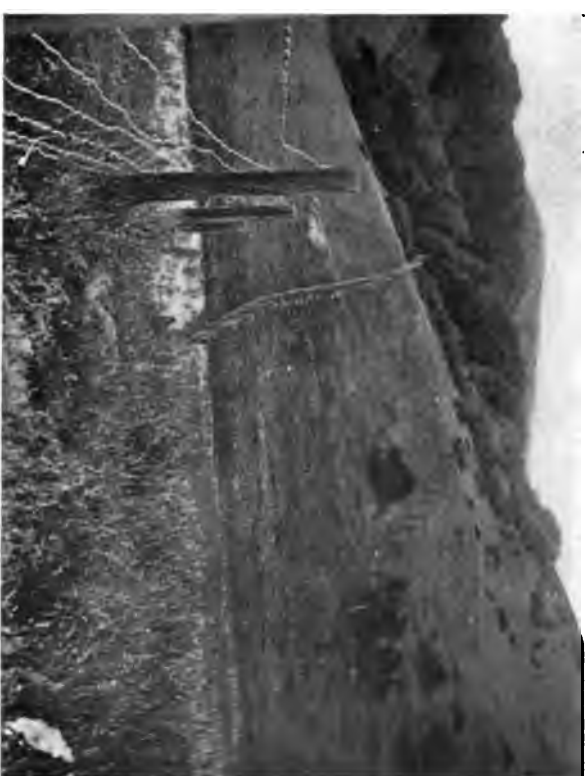
D. Offset of 6 feet in fence between San Andreas and Crystal Springs Lakes. Per J. O. B.

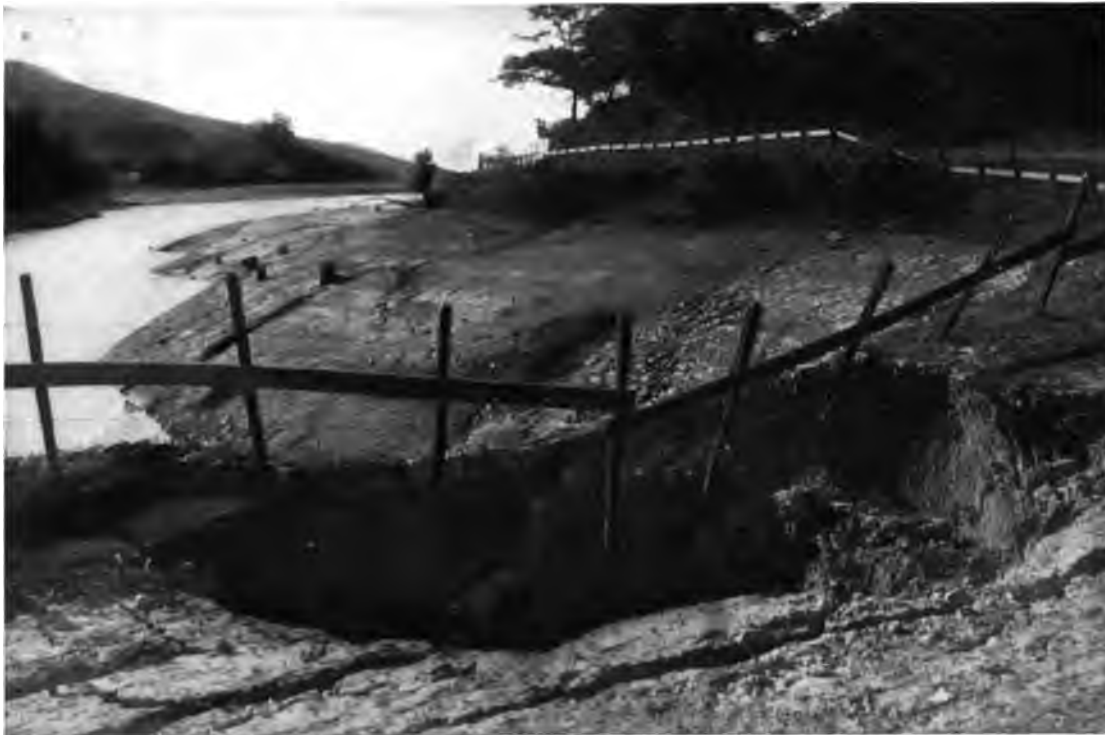
*South of Congress Springs.* — Near and northwest of the reservoir 2.5 miles southeast of Congress Springs, fissures from 4 to 6 feet wide ran nearly north and south, and past thru the earthen dam at the northwest end of the reservoir. (Plate 64A.) The intake pipes at the south end of the reservoir were disconnected, and the escaping water undermined a part of the southern dam of the reservoir. This reservoir is in a topographic saddle and has dams at both ends. The fault-trace passes thru this saddle. Where the bottom of the reservoir was exposed by the escape of the water, cracks of the fault-trace were exposed in the mud. Fences crossing the fissures showed but little displacement; the displacement moved the northeast side toward the southeast, relatively. The hills southeast of the reservoir have steep slopes of from 20 to 50 degrees. The cracks follow the east-facing slopes and the east side of these cracks had raised about 6 or 8 inches. Southeast of the reservoir the chimneys and water-tanks were down.

A. Reservoir in saddle south of Saratoga traversed by main fault. D.

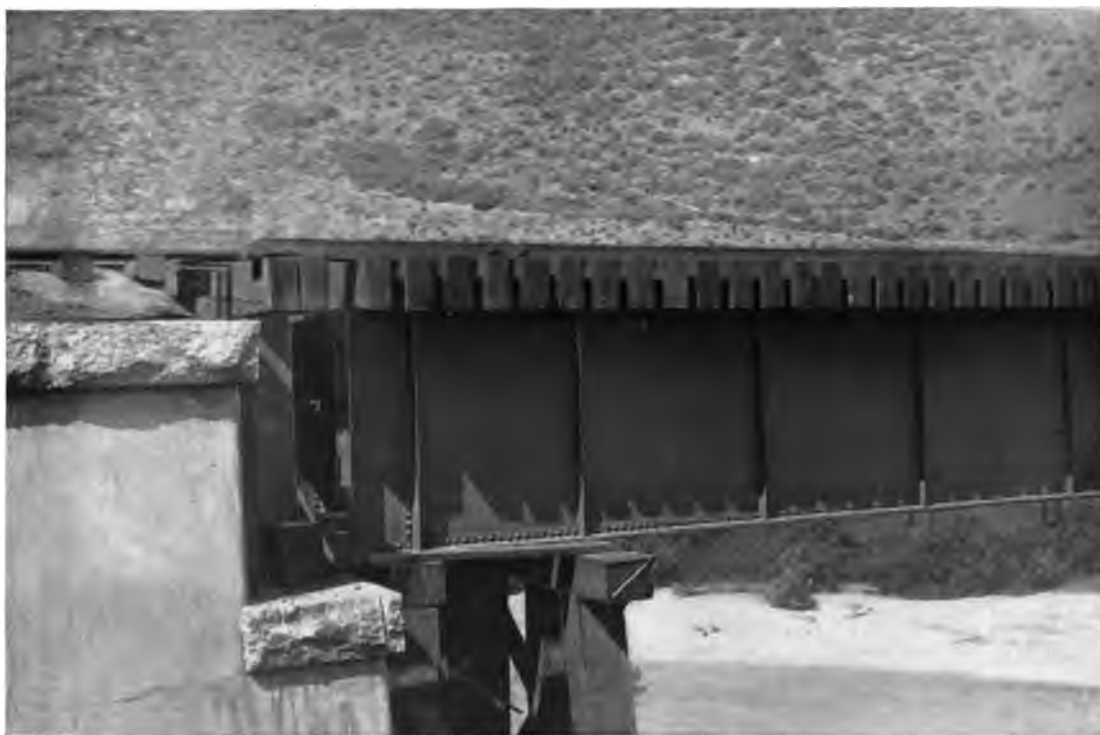
B. Steel bridge over Pajaro River, near Chittenden, dragged from its abutment 3.5 feet. Compare Fig. 43. A. C. L.

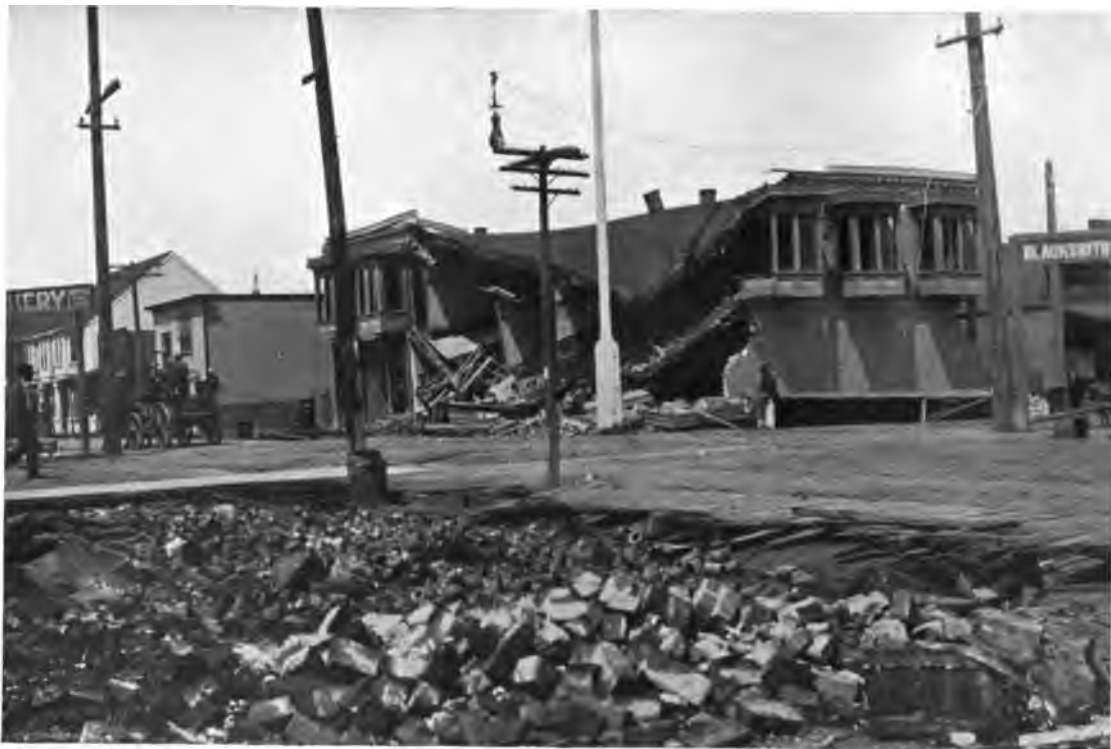
B. Wrecked buildings, Fort Bragg. Looking northwest.

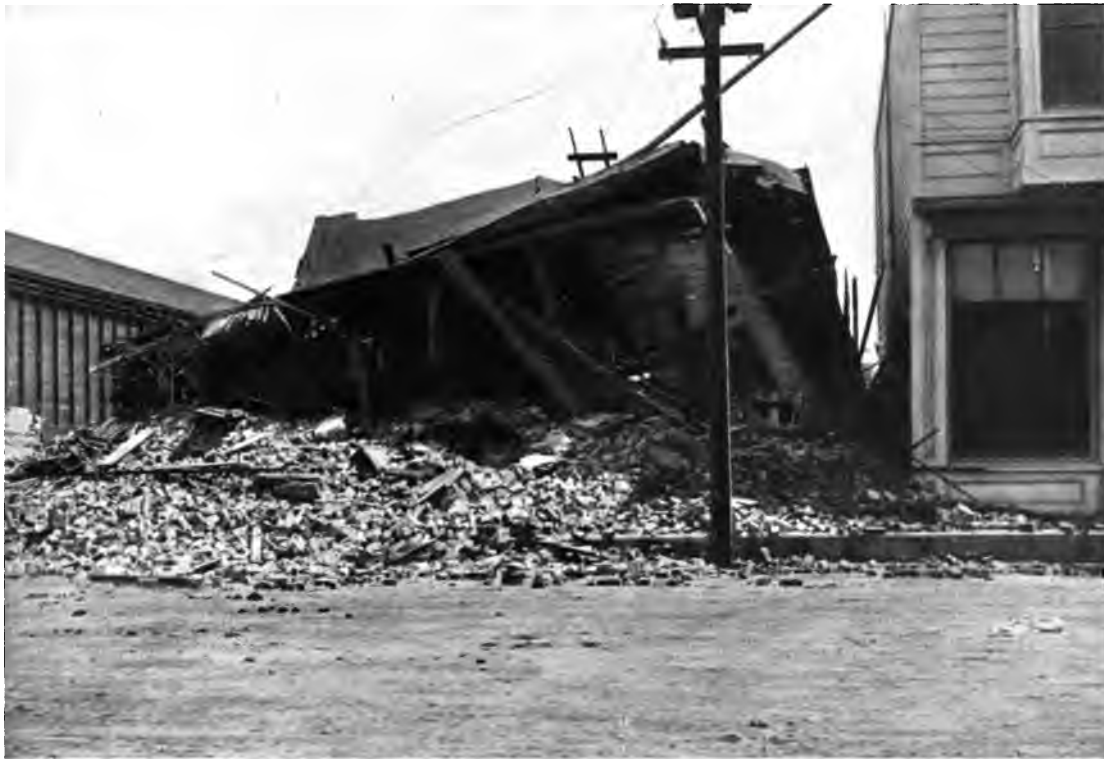
A. Odd Fellows' Hall, a 3-story brick building. Fort Bragg. Looking east.

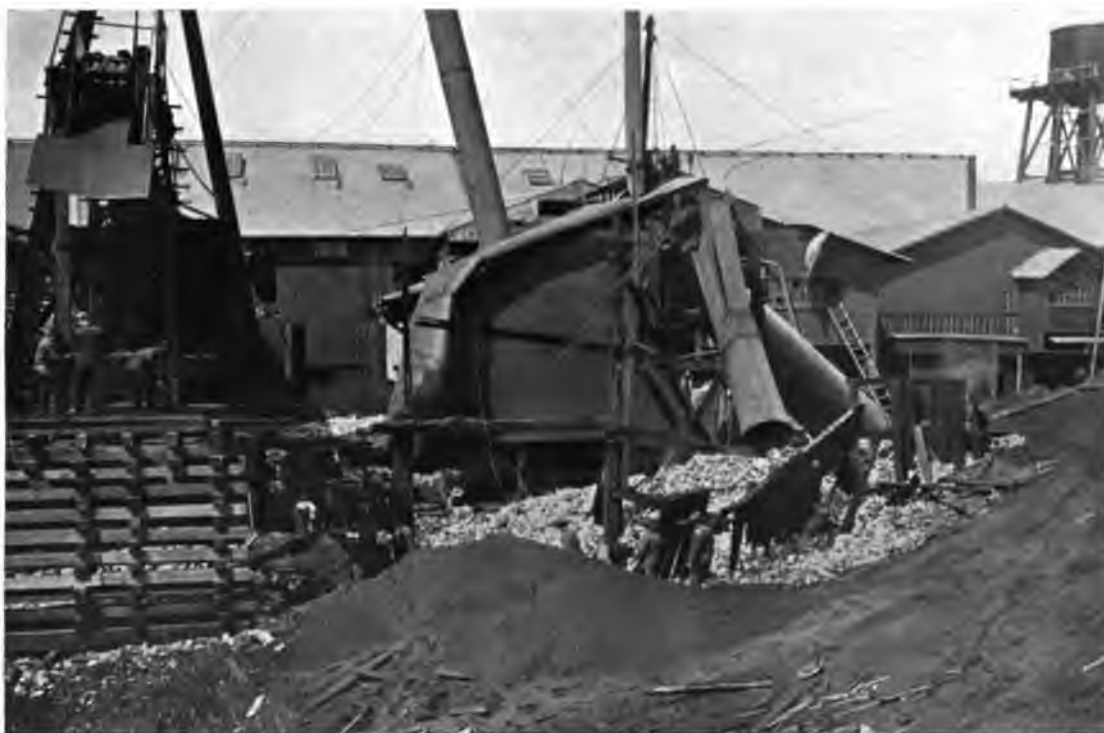
B. U. C. Co.'s mill, Fort Bragg. Smoke stack 5 feet in diameter. Entire structure thrown out of plumb to south, 1 foot in 20 feet.

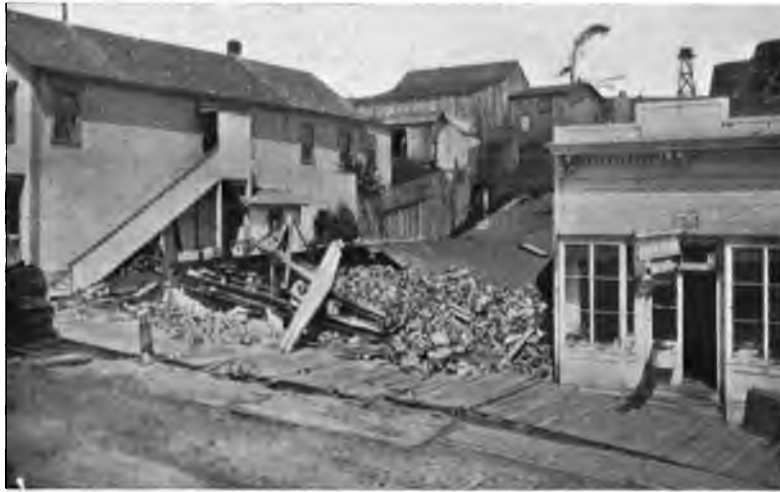
A. Point Arena. Brick house destroyed; wooden houses little affected. F. E. M.

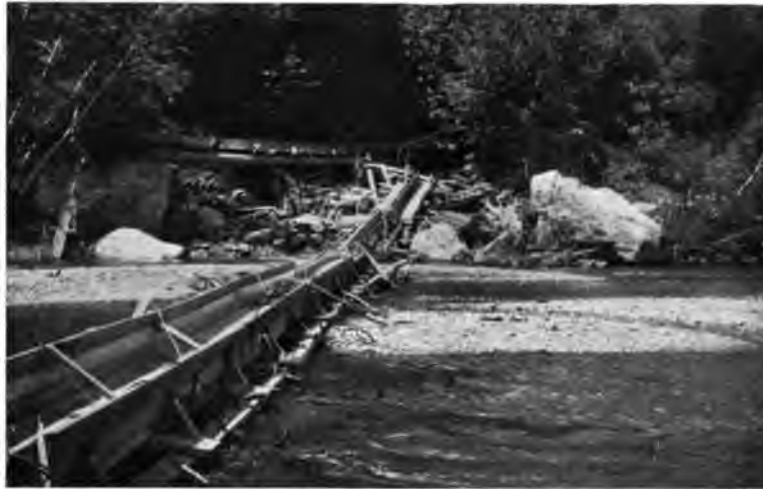
B. Wreck of suspended flume across Garcia River. Looking west. F. E. M.

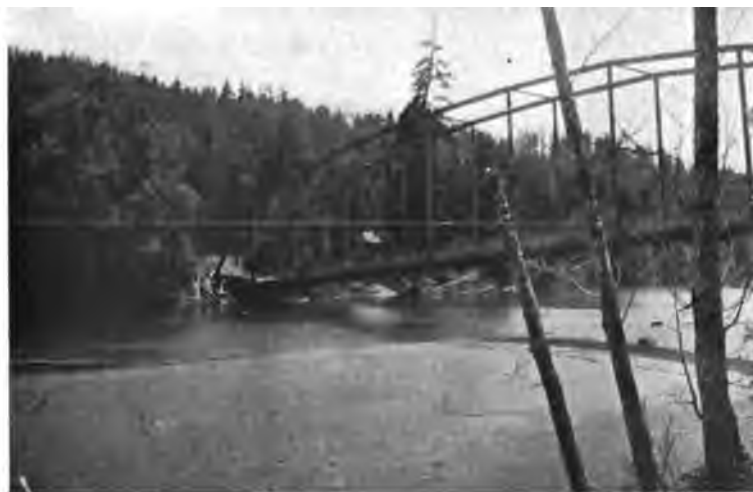
C. Collapsed wagon bridge over Gualala River. South end dropt 20 feet. F. E. M.

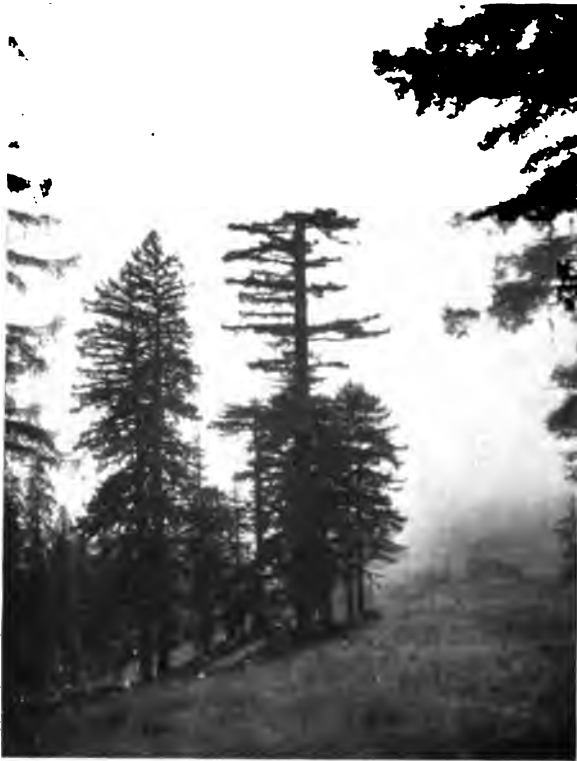
A. Sound redwood tree snapt off 42 feet from top. Near Fort Ross. F. E. M.

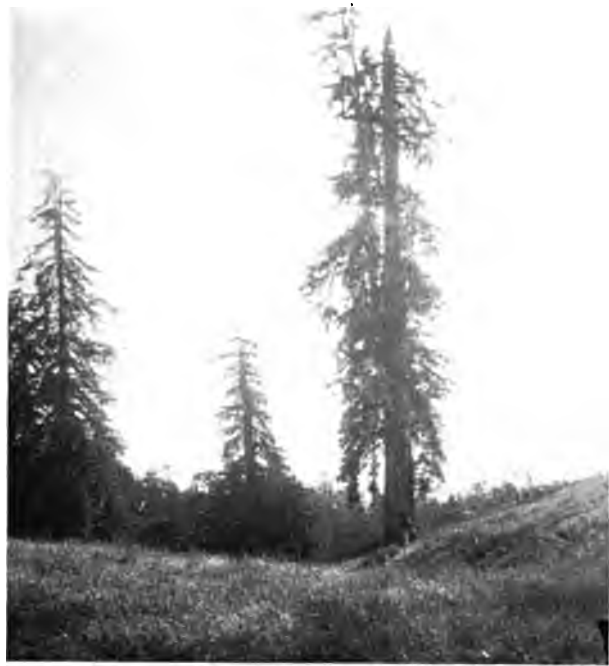
B. Redwood tree snapt off. Locality, 0.25 mile east of fault above Fort Ross. F. E. M.

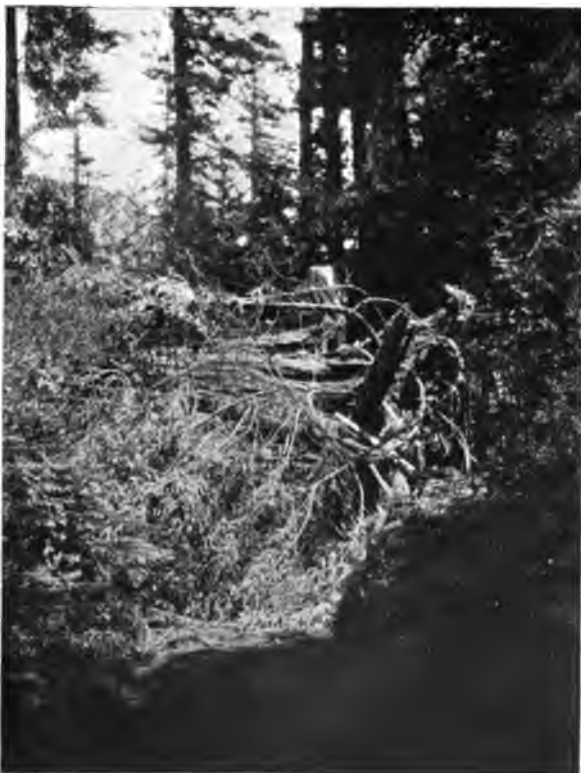
C. Uprooted tree, 8 feet in diameter, 187 feet long, about half mile west of Garcia River, on road to Garcia Mill. Tree sound. F. E. M.

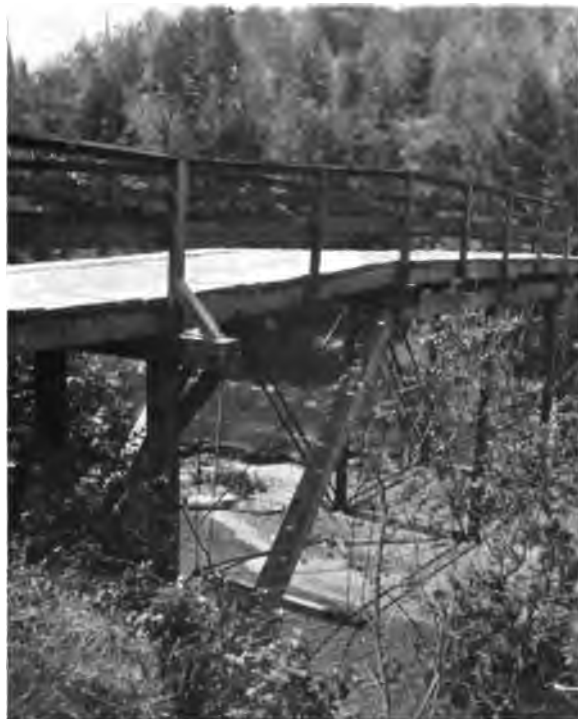
D. Bridge over South Fork, Gualala River, 3 miles east of Stewart's Point, looking north. Bridge floor and panels bent; tension rods buckled. F. E. M.

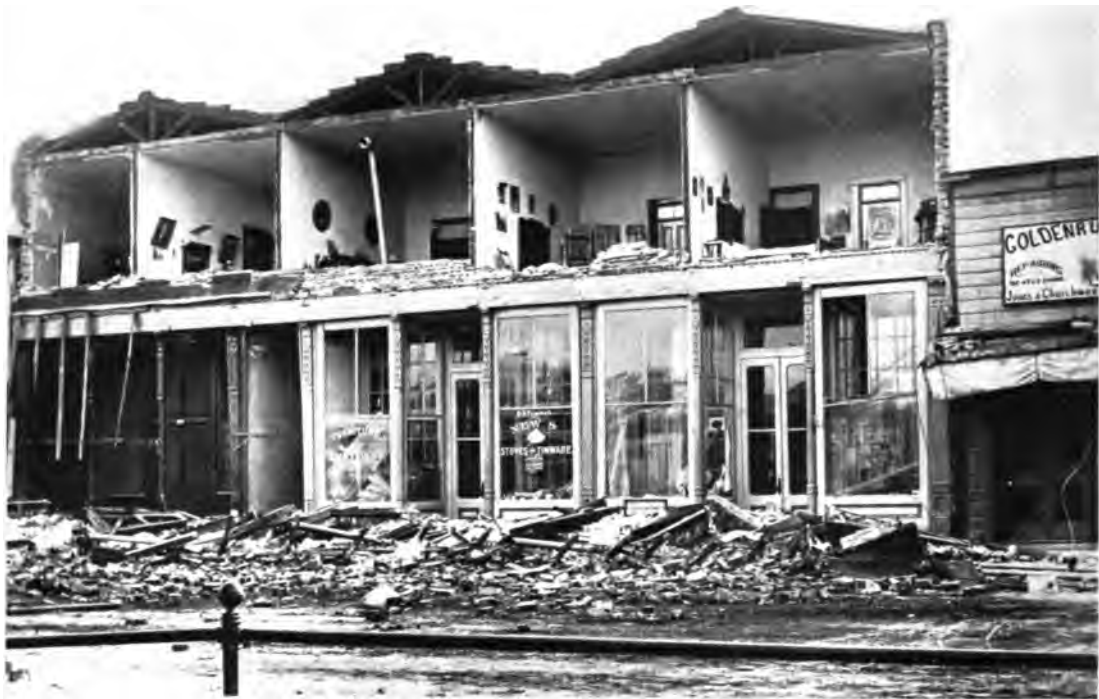
A. Bell and Kinslow building, Healdsburg. Per J. O. B.

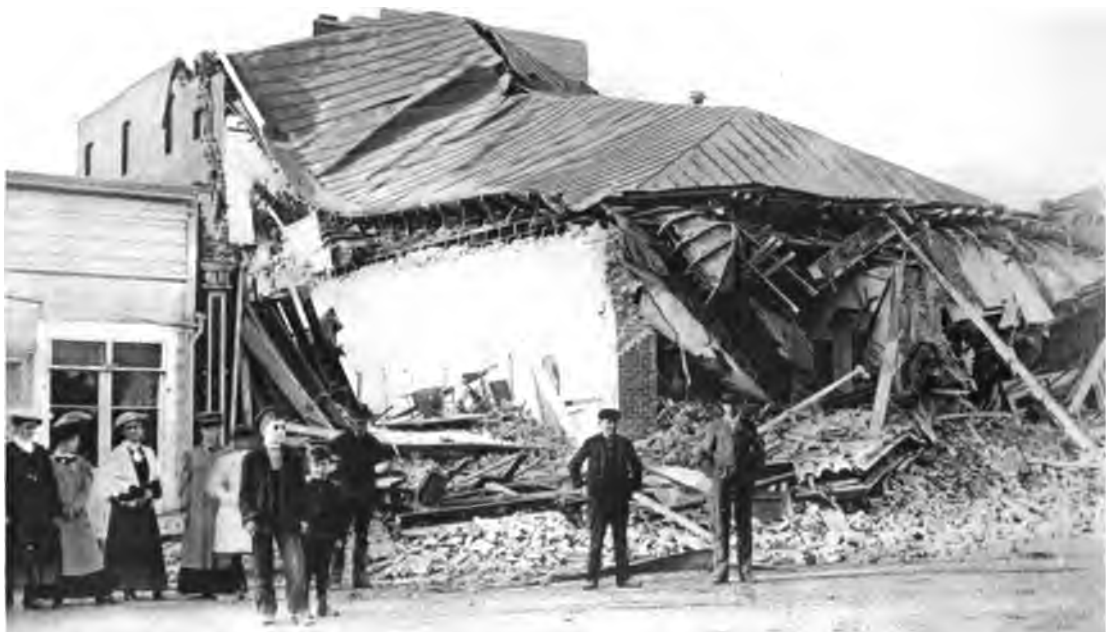
B. Odd Fellows' Hall, Healdsburg. Per J. O. B.

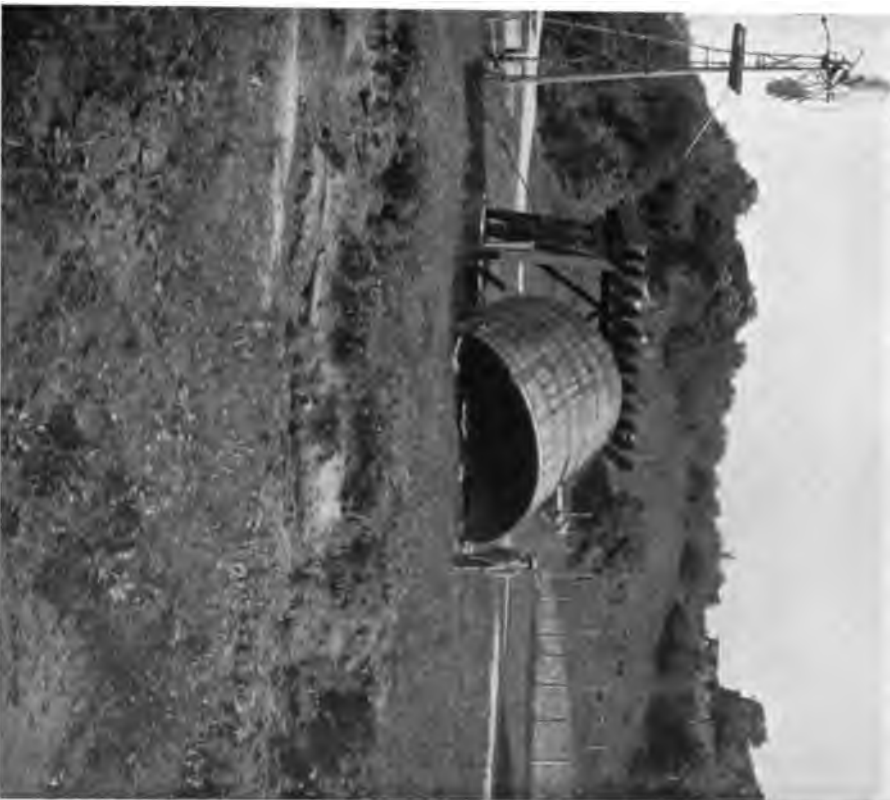
B. Wrecked water-tank, near Inverness. G. K. G.

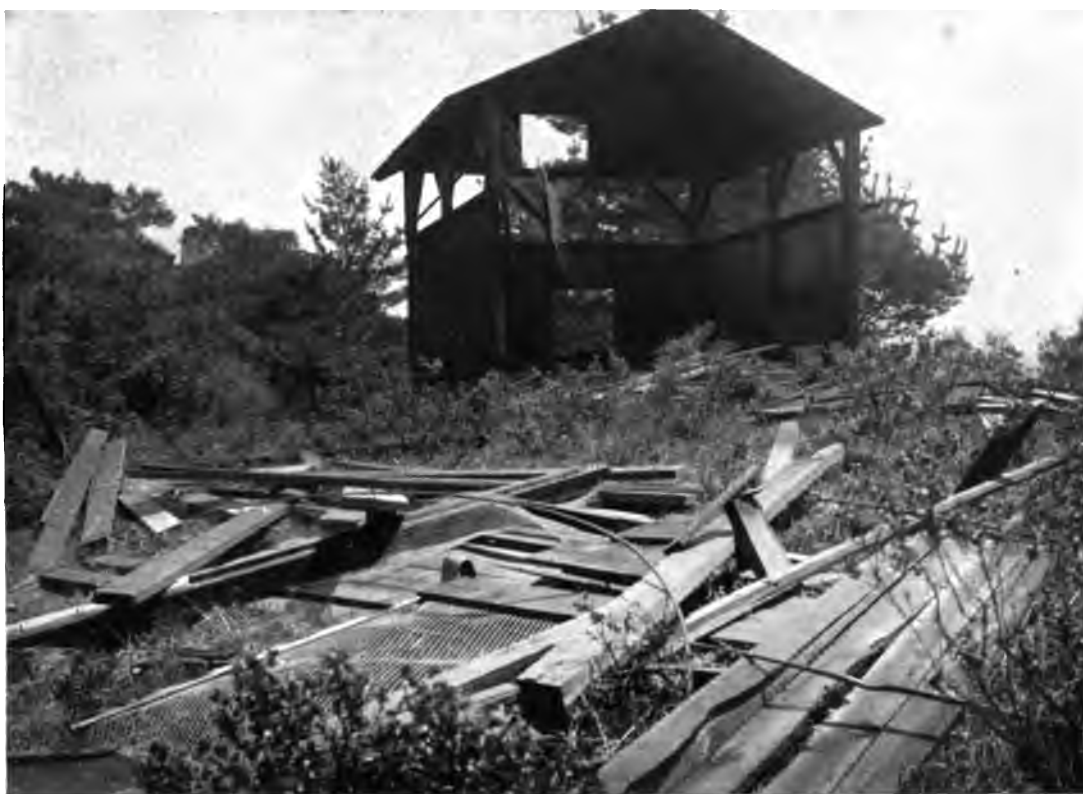
A. Ruin of Inverness reservoir, a circular tank which before earthquake stood in shed. Parts of shed also lie in foreground, about 50 feet from original position. G. K. G.

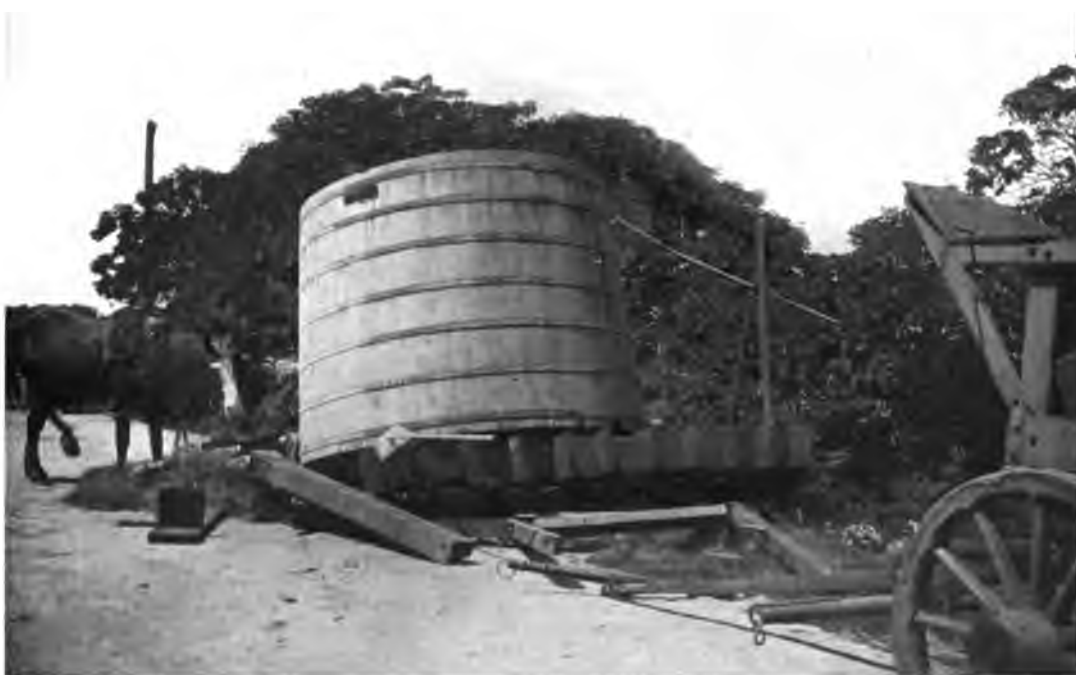
B. Wrecked water-tank near Inverness. G. K. G.

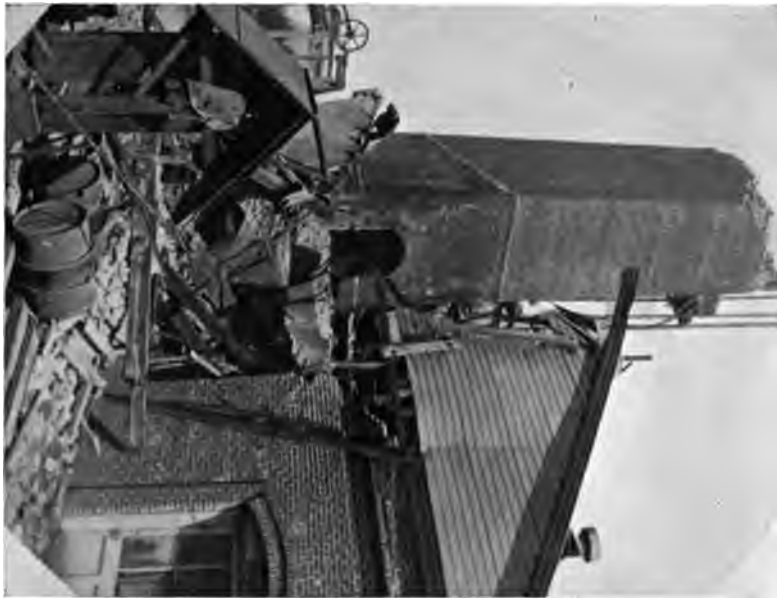
A. Cold-storage plant, Petaluma.

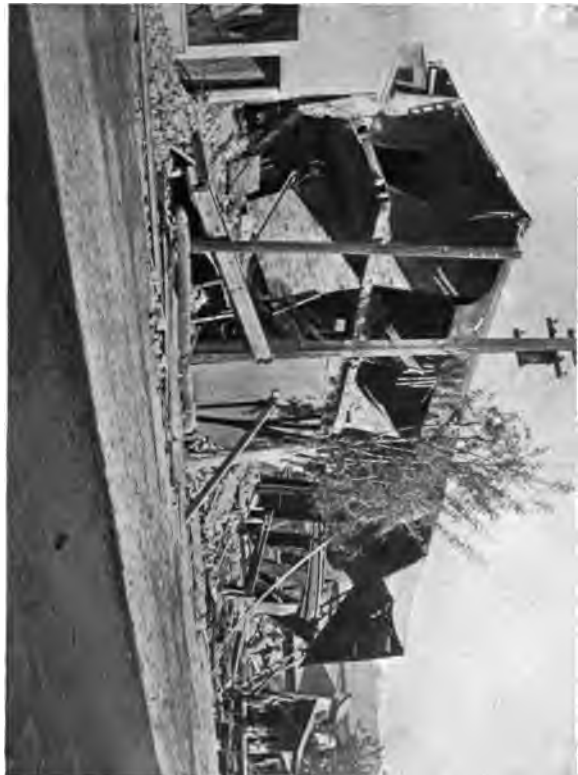
B. Buckner Hotel, Willits. R. S. H.

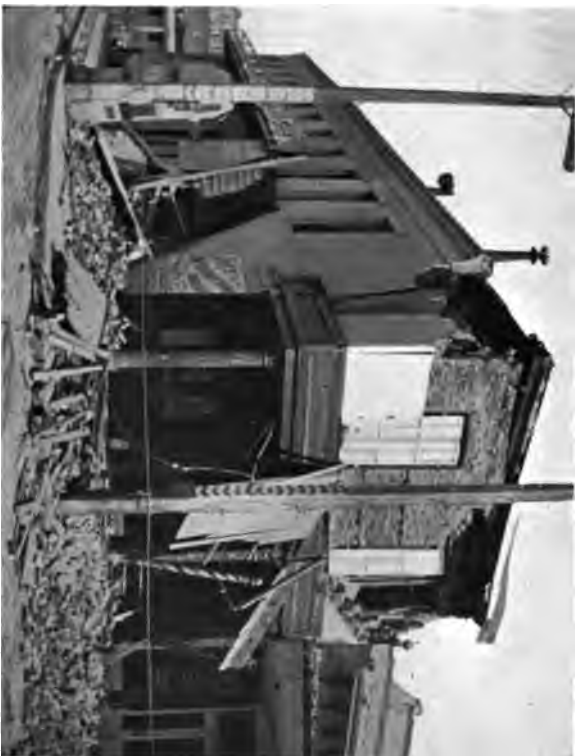
C. Corner Main and Washington Streets, Petaluma.

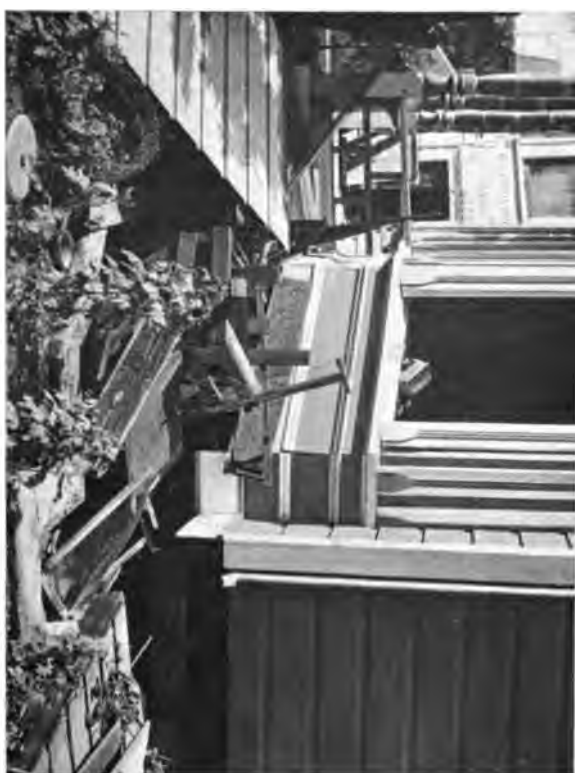
A. House moved 7 feet by collapse of underpinning, Santa Rosa. R. S. H.

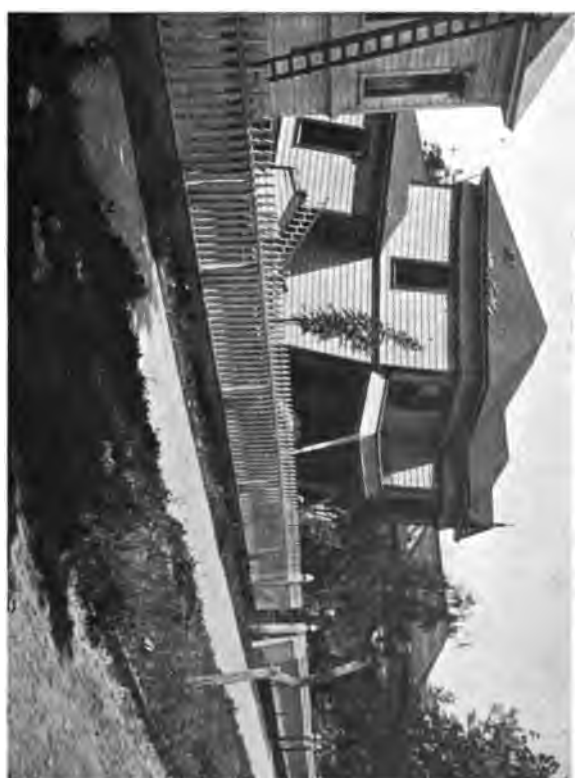
B. House lurched to north, Santa Rosa. R. S. H.

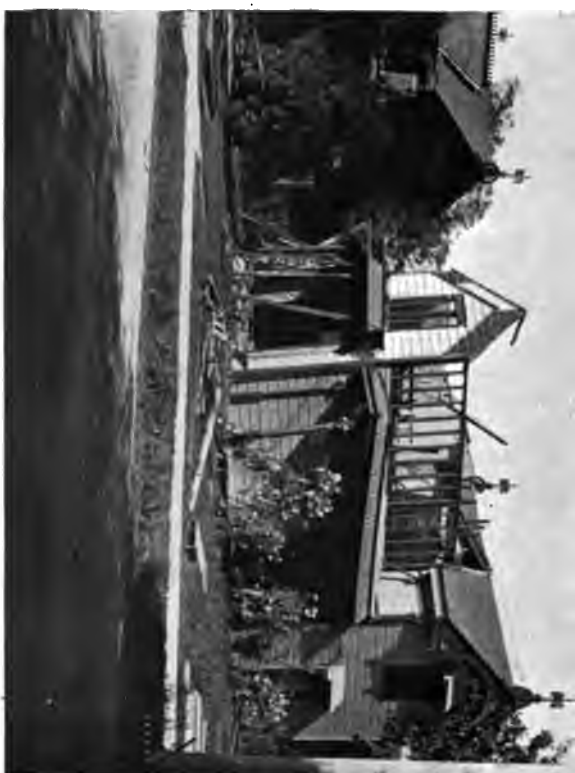
C. Wrecked dwelling, Santa Rosa. R. S. H.

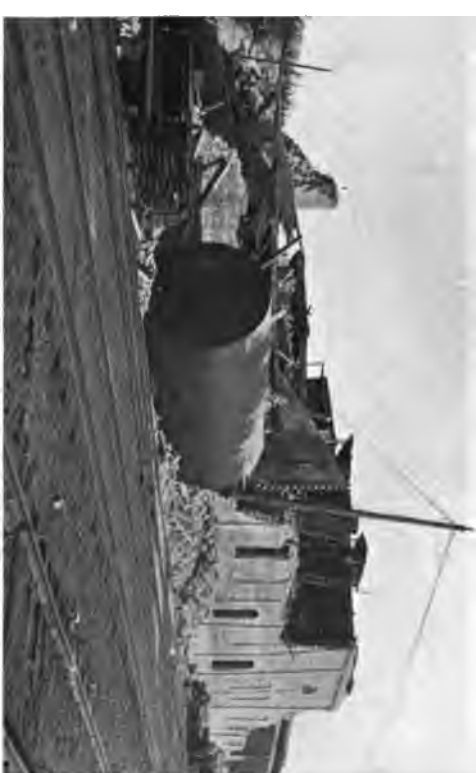
D. Wreck of brick structure, Santa Rosa. R. S. H.

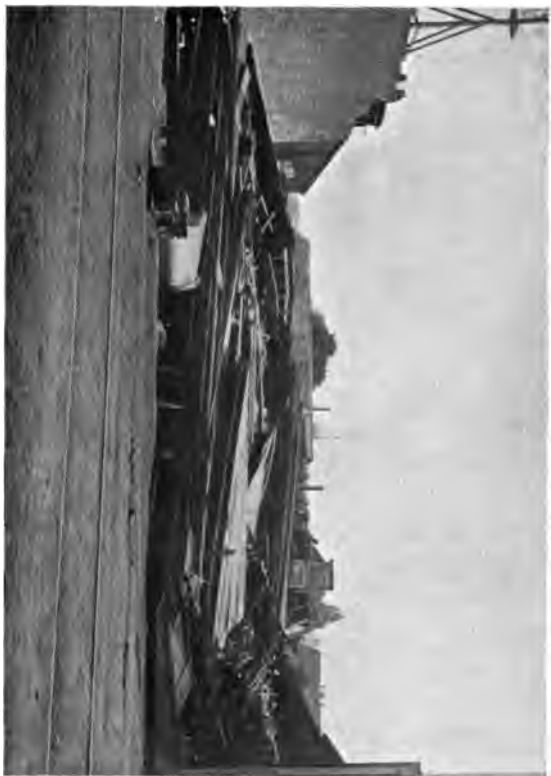
A. East side of main street, Sebastopol. R. S. H.

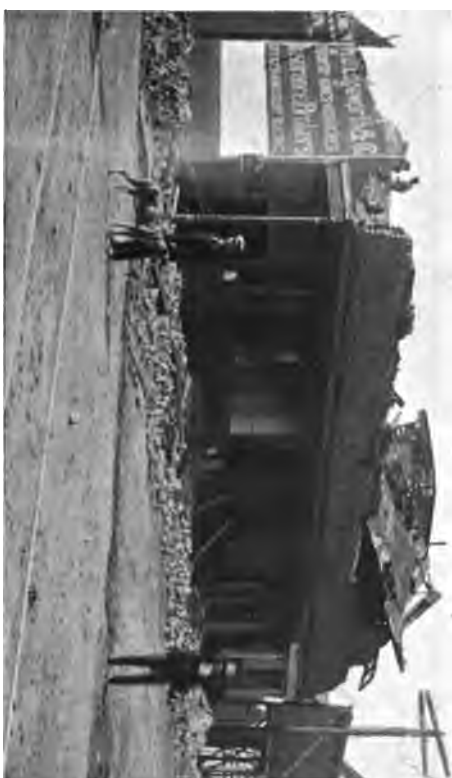
B. Wrecked building, Sebastopol. R. S. H.

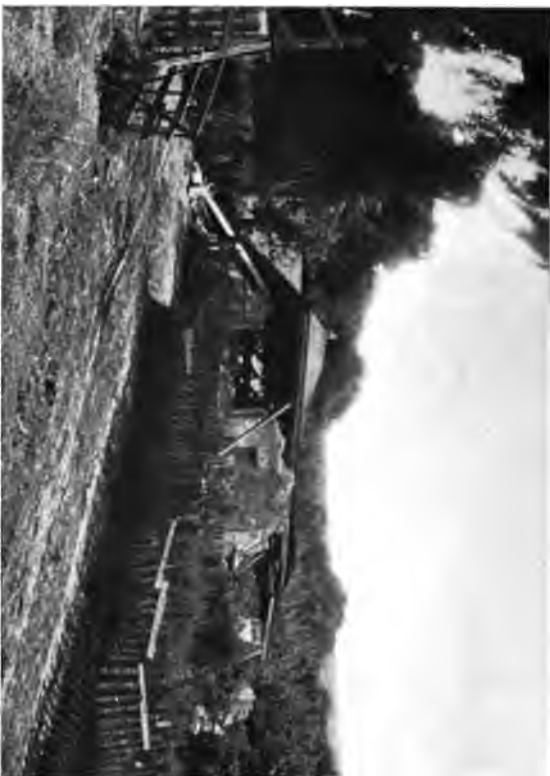
C. Stone house 1.5 miles southeast of Tomales, where two people were killed at time of earthquake. R. S. H.

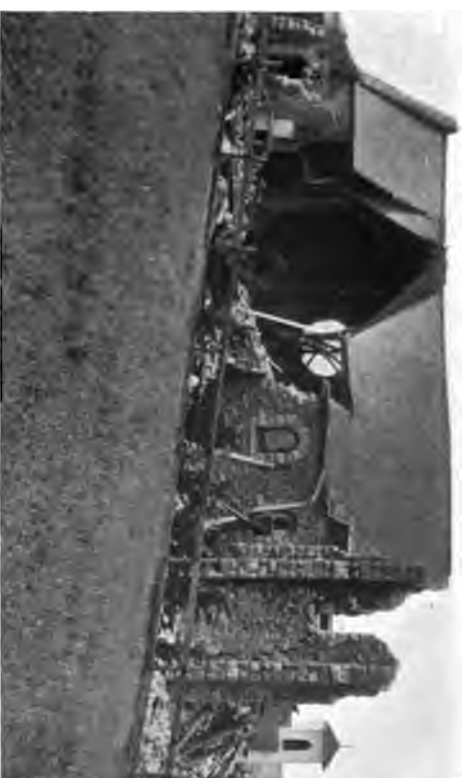
D. Wrecked church, Tomales. R. S. H.

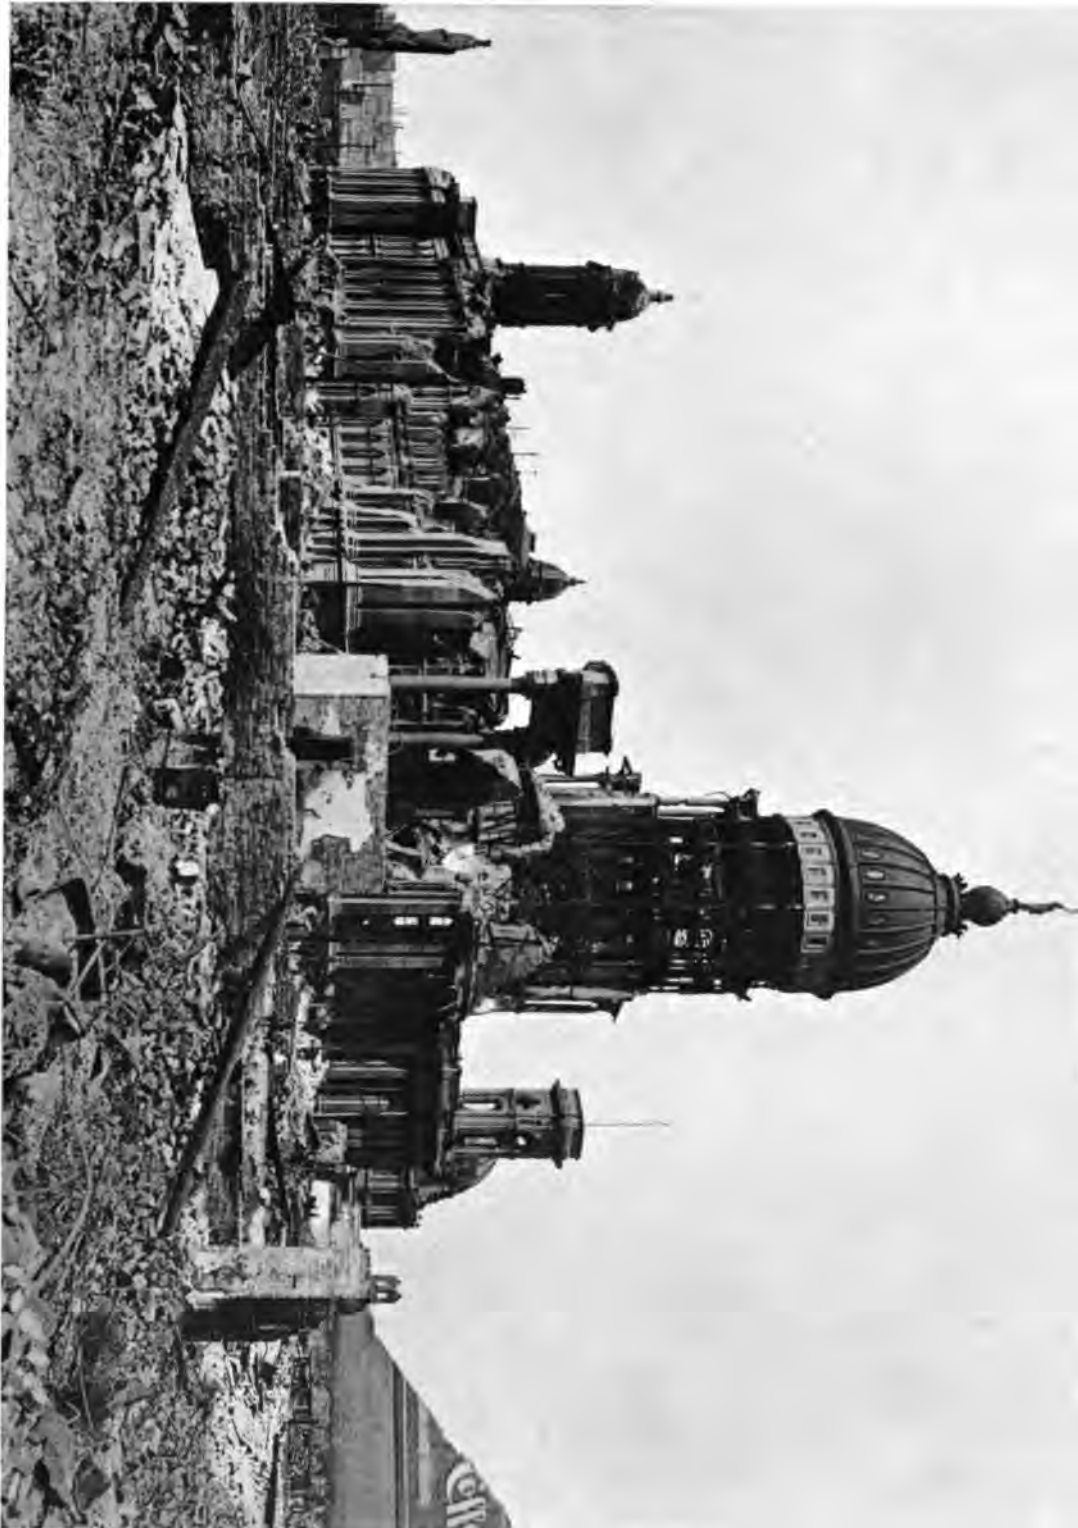
City Hall, San Francisco.

Near the City Hall there was a small locality conspicuous for the damage produced. The City Hall itself made a picturesque ruin (plates 82 and 83A), as all the world knows, but the character of the construction was probably a large factor in its destruction. Nevertheless ugly cracks in other buildings near by indicated intensity somewhat higher than was common in the valley district as a whole.

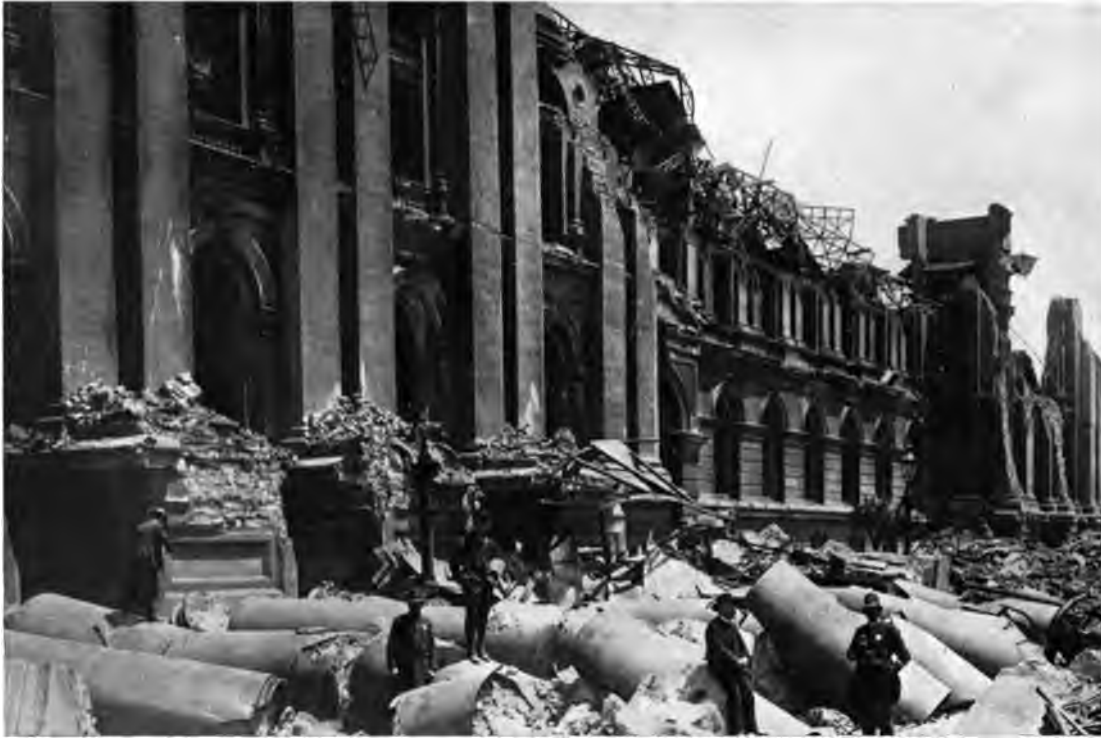
A. A near view of the wreck at the City Hall, San Francisco.

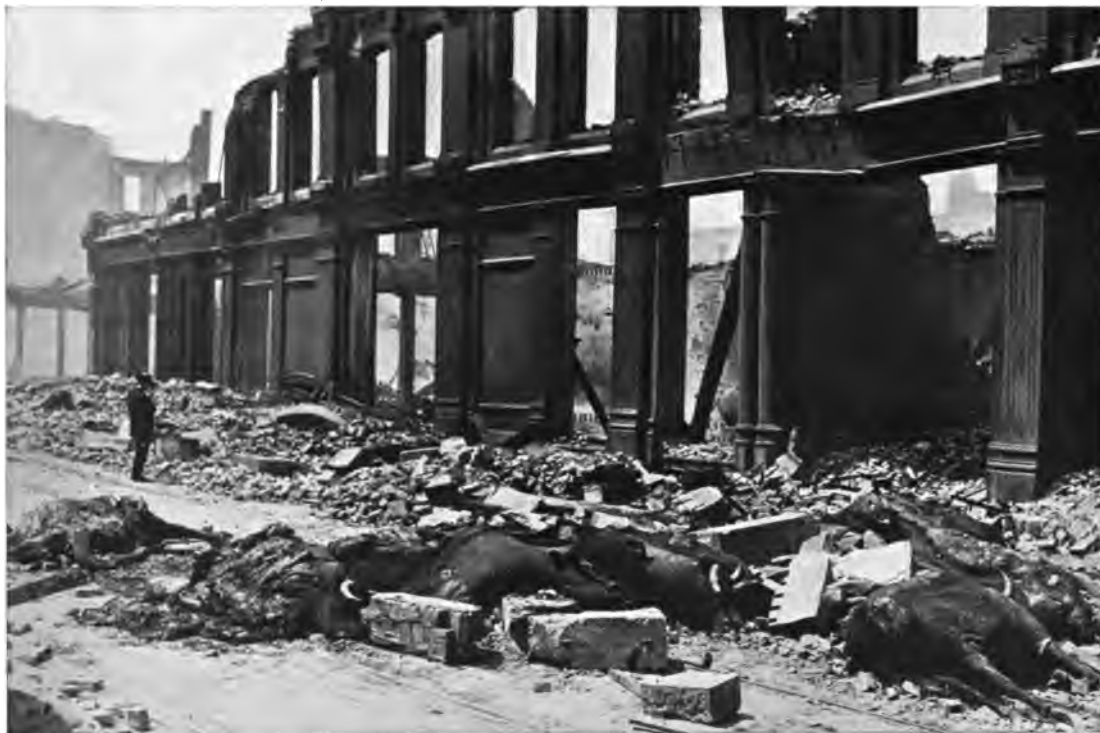
B. Cattle killed by falling masonry at time of earthquake, San Francisco.
